TileCal-IFIC Upgrade Project Meeting

09/03/2026

Carrier Batch 23-1025-005 to 008 Validations

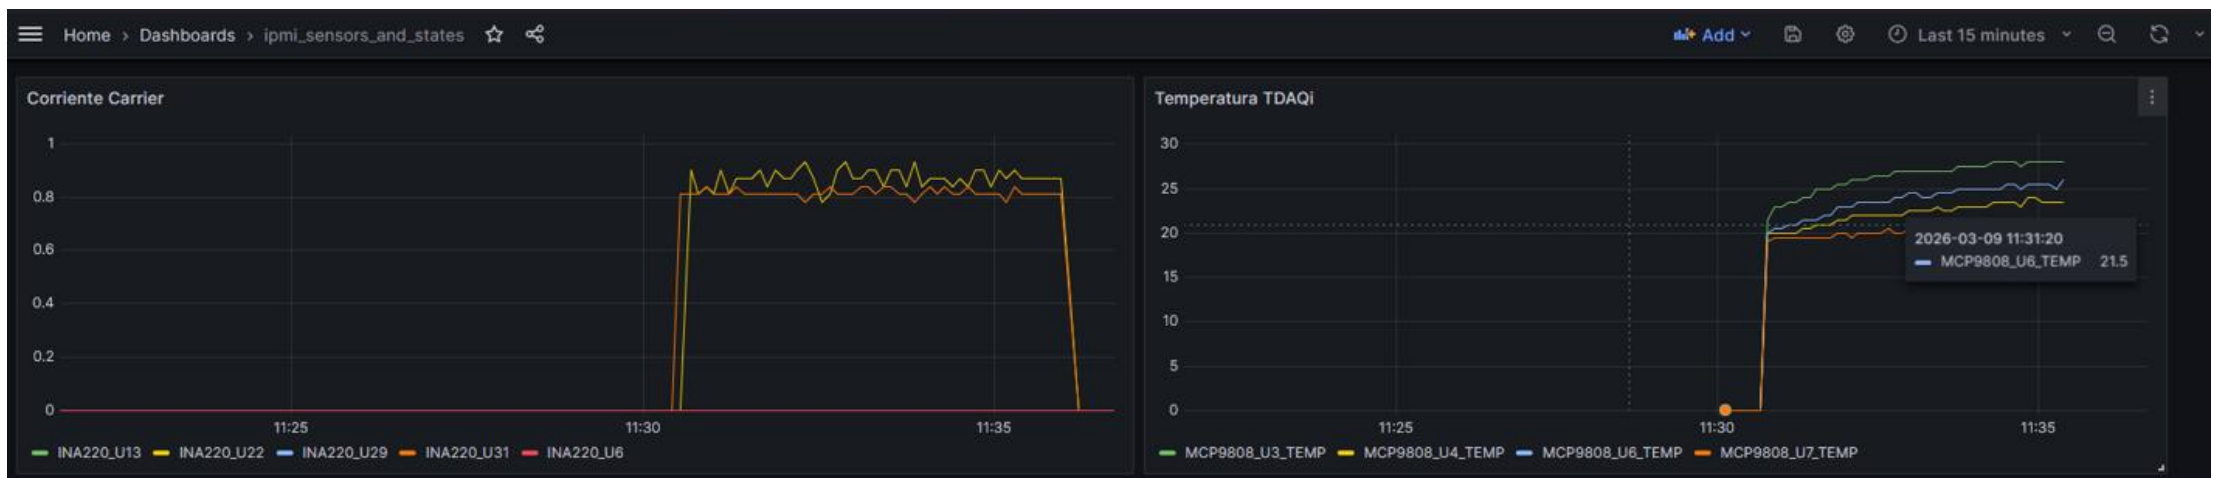
IBER Tests on the Carriers

- To verify the links of each carrier, an **IBER test** is being performed, **checking all links** of every slot for 3–4 hours per link.
- During these tests, a **power loss** issue was observed in TDAQI and CPM.
- A **Grafana** setup with InfluxDB was deployed to monitor possible errors in the current and temperature sensor readings.
- After analyzing the data, the issue was identified as a **firmware problem** in the MMC (according to Fernando), not a hardware failure.
- For the tests we are doing now, this problem can be fixed by **loading an older firmware** version.
- The Grafana structure is useful for monitoring the carriers without relying on TileCom, and all monitoring actions are performed with **ipmitool commands via the shelfmanager**.

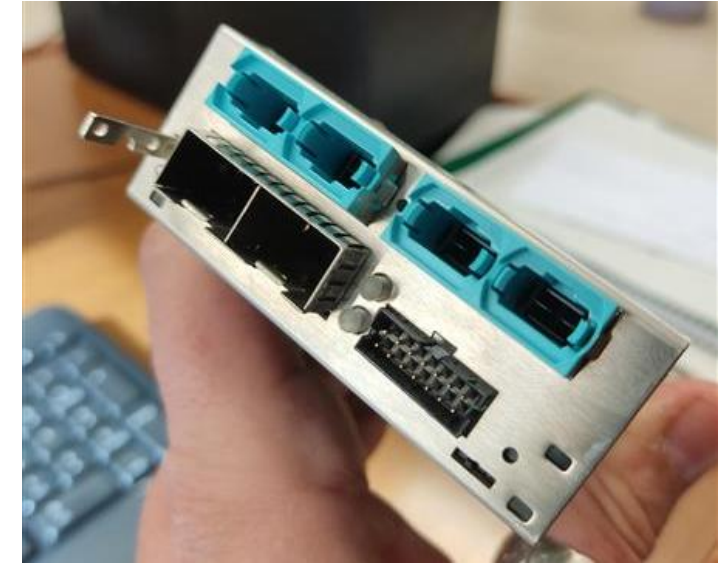
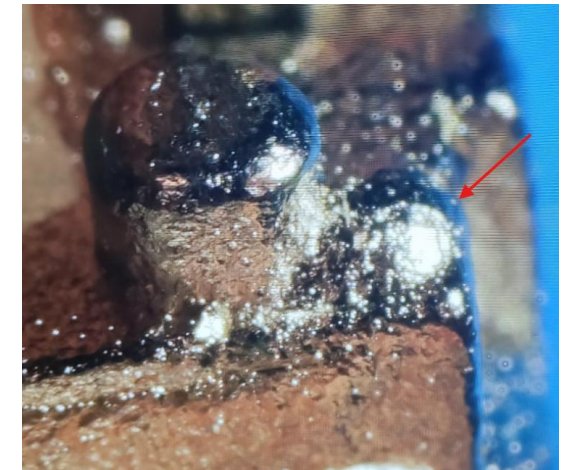
Front Panel Machining Issues

- Several front panels were sent for machining, but the Mechanical Workshop at IFIC made the incorrect holes position and lower dimensions, and the pieces had to be remanufactured.
- The lower holes also needed an additional **0.2 mm** on each side to ensure the parts could fit properly.
- A locating pin was also found to interfere with the correct assembly of the pieces, and it must be filed down before mounting.
- After applying all these modifications, the final part fits correctly and all components assemble as expected.
