# TileCal-IFIC Upgrade Project Meeting

David Hernández Navalón

28/07/2026

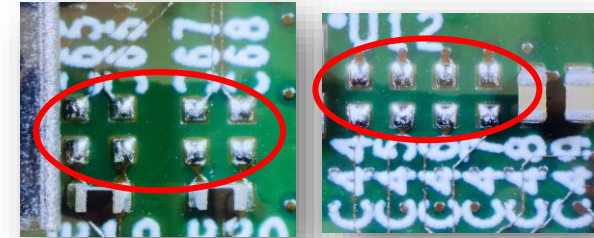
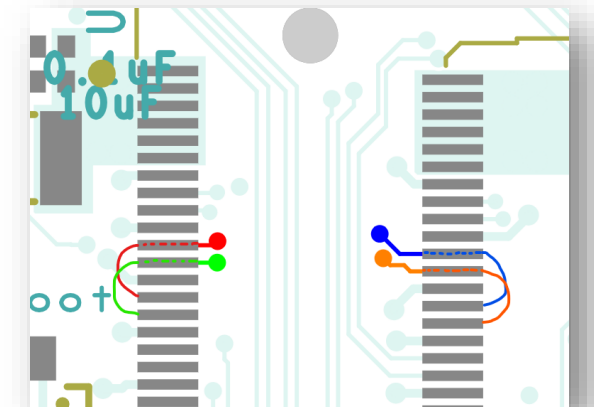
- The TileCom system has three Ethernet interfaces.
- None of the three interfaces was correctly detected in PetaLinux.
- All ping tests failed.

- After some debugging, we found:
  - Missing capacitors on the high-speed lines.
  - Incorrect routing on the carrier.
  - The Marvell TX port and one Vitesse TX port were connected to the same PS interface.

- Moved the Vitesse interface to GEM2.
- Corrected the PHY addresses.
- All three Ethernet interfaces are now working:
  - ✓ • GEM0 uses the Vitesse PHY through the carrier GbE switch.
  - ✓ • GEM1 uses the on-board Marvell PHY with RGMII-ID.
  - ✓ • GEM2 uses the second Vitesse port through direct SGMII.

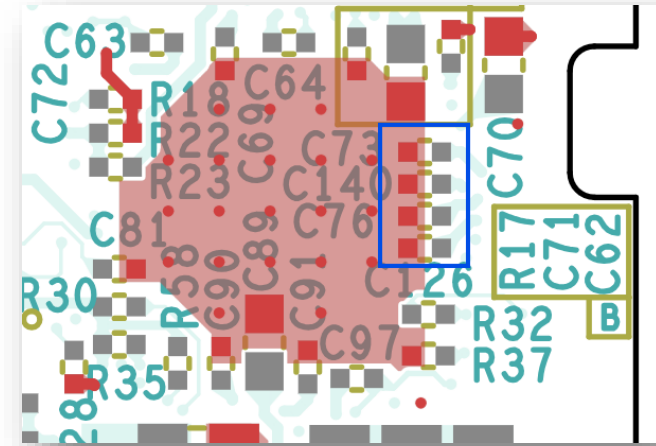
- Tilecom reset problems:
  - Tilecom decoupling capacitors were connected to the TPS thermal pad which generates noise.
  - We moved the decoupling capacitors from the TPS thermal pad to a direct GND connection.
  - These changes allowed stable operation up to 12.8 V.
- ✓ • One TileCom was recovered after these modifications.
- ✗ • The second TileCom probably has a short circuit inside the FPGA and appears not repairable.
- Two TileCom motherboards were assembled for testing.

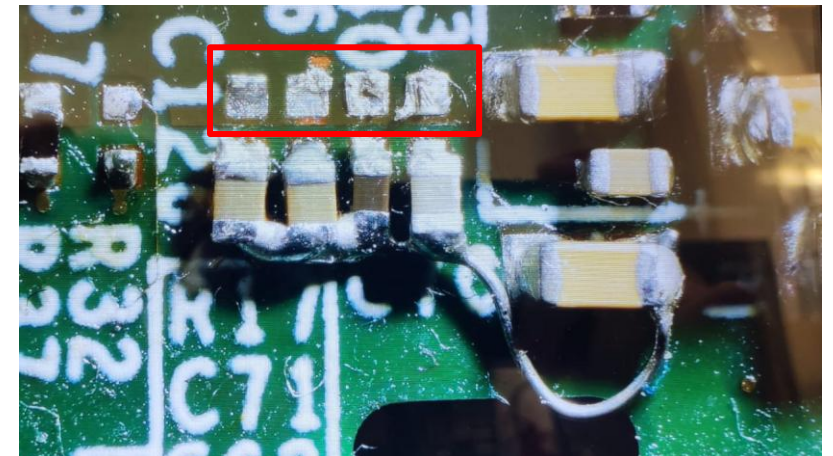
- Were removed the LTC2954 component because there is no physical shutdown button.
- This function was replaced with a new power-cycle circuit.
  - The circuit uses GPIO pin to control signal reset.
- ✓ • The solution was successfully tested.
- The Linux command is available as `/usr/bin/powercycle`.

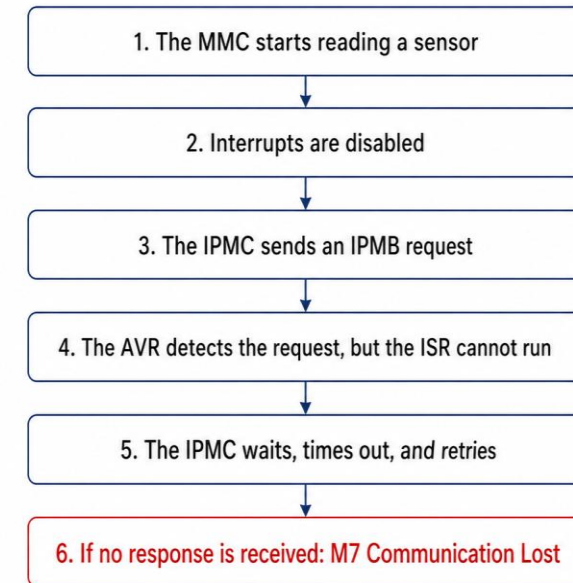
### Sequence leading to M7 Communication Lost

- Developed a script to monitor the TDAQi.
- The problem appears after several hours with multiple CPMs.
- TDAQi reached **M7**, followed by another AMC.
- About one minute later, the carrier payload powered off.

- Compared the CPM, TDAQi and IPMC firmware.
- Found possible IPMB communication issues.
- Two recent TDAQi commits may be related to the problem.

- Revert the I<sup>2</sup>C changes.
- Test the TDAQi alone and with different AMC combinations.
- Compare the firmware before and after the suspicious commits.
