# TileCal-IFIC Upgrade Project Meeting

David Hernández Navalón

22/09/2026

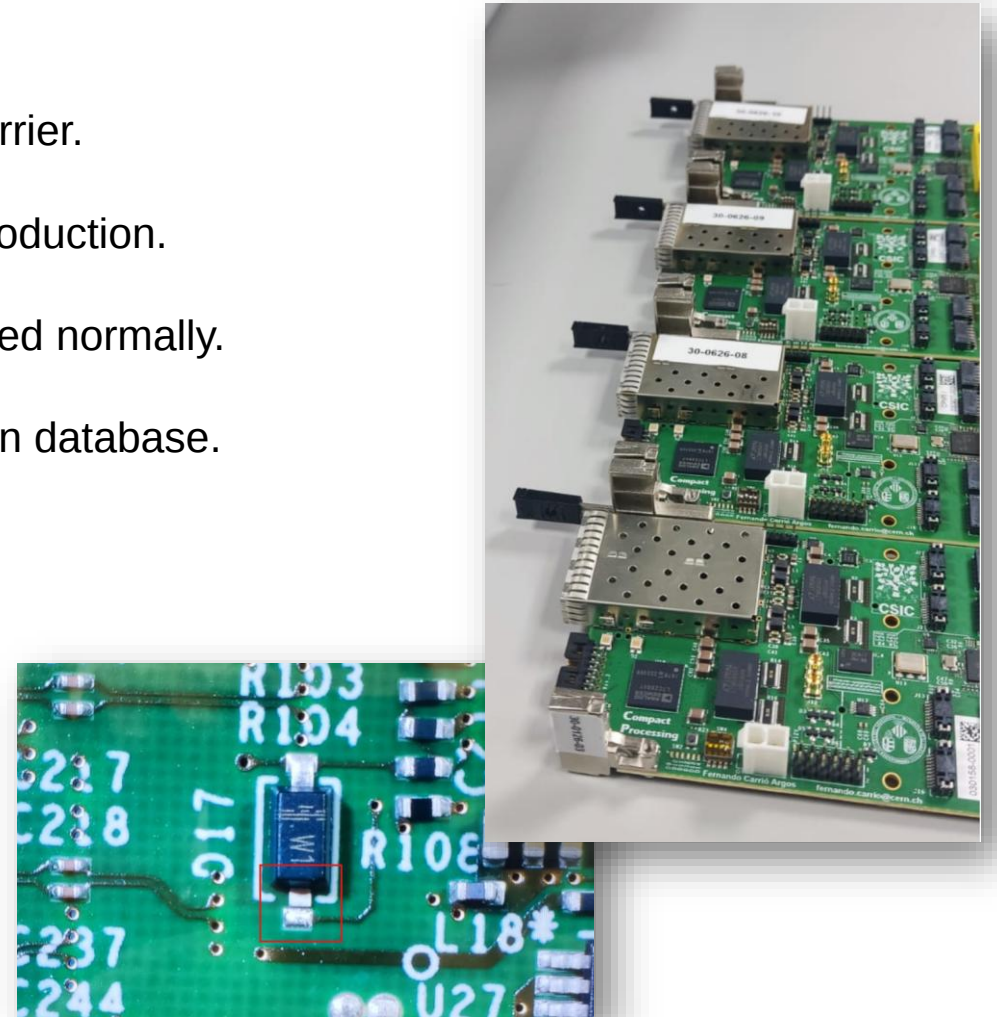
- I validated four CPMs before sending them to CERN.
- One CPM did not receive payload power when I inserted it into the carrier.
  - I found that diode *D17* had been **incorrectly soldered** during production.
  - ✓ • After resoldering it, the CPM received payload power and operated normally.
- I also registered the CPMs and their current locations in the production database.
- Finally, the four CPMs were prepared and sent to CERN for the **PRR**.
  - CPM-30-0626-08
  - CPM-30-0626-09
  - CPM-30-0626-10
  - CPM-30-0126-03

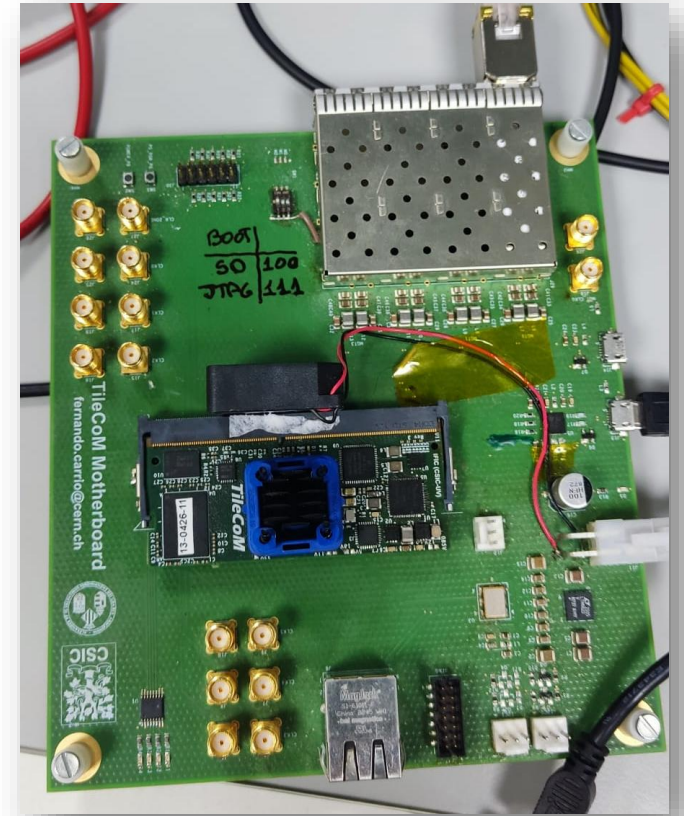
- Clermont sent us TileCom (TCO-13-0426-09) because it sometimes failed to boot correctly.
  - The problem appeared after configuring the clocks.
  - They had to restart the TileCom several times before it booted correctly.
  - Following our recommendation, they separated the decoupling capacitors from the TPS thermal pad -> but the problem continued.
- I tested the TileCom with two different configurations.
  - Our usual SD card image.
  - The SD card image provided by Clermont.
- I also tested different power and connection conditions.
  - A laboratory power supply between 11 and 13 volts.
  - The TileCom connected to a carrier on the laboratory bench.
- The TileCom booted correctly in all our tests.
  - We could not reproduce the problem observed in Clermont.
  - I am currently analysing the Ilana motherboard schematics and comparing the connections to find a solution.
