TileCal-IFIC Upgrade Project Meeting

09/03/2026

Carrier Batch 23-1025-005 to 008 Validations

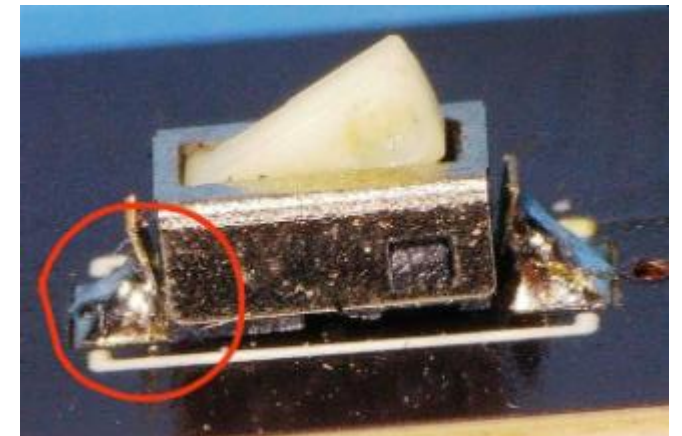
- Based on the carrier test results, the new carrier assembler performs much better than the previous one, with far fewer errors, except for the LED issue.
