# TileCal-IFIC Upgrade Project Meeting

David Hernández Navalón

28/07/2026

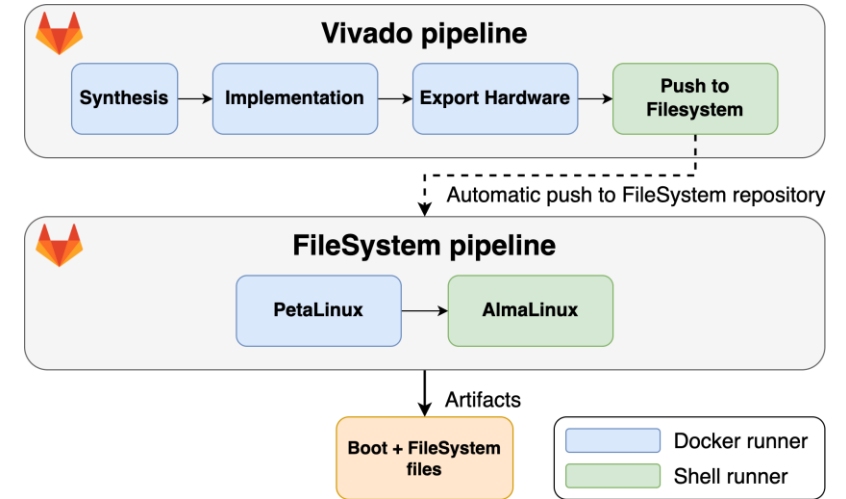
- I validated the complete Vivado and PetaLinux build pipeline.
- The pipeline generates all the files for the root file system.
- ✓ • Finally, I tested the generated image on TileCom using an SD card.

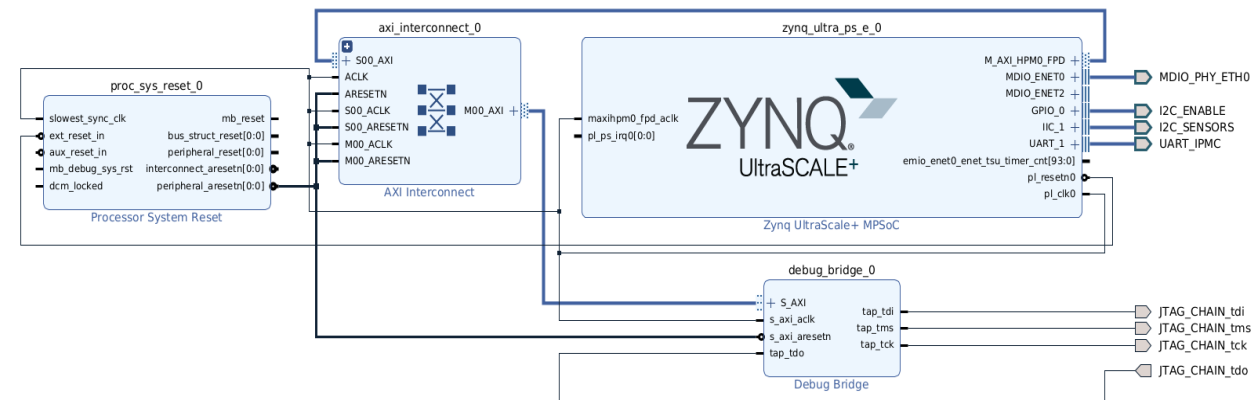
- ✓ • The AXI Debug Bridge and Xilinx Virtual Cable were implemented with help from Héctor.
  - This provides access to the carrier JTAG chain through the TileCom with Vivado.
- ✓ • As an additional improvement, OpenOCD was integrated into PetaLinux
  - enabling JTAG operations without Vivado.
- To control OpenOCD, the jtagtool script was implemented.
- The script can:
  - Scan the complete JTAG chain.
  - Identify CPM and TDAQi FPGAs.
  - Show the detected devices and their positions.
  - Program one selected FPGA without Vivado.

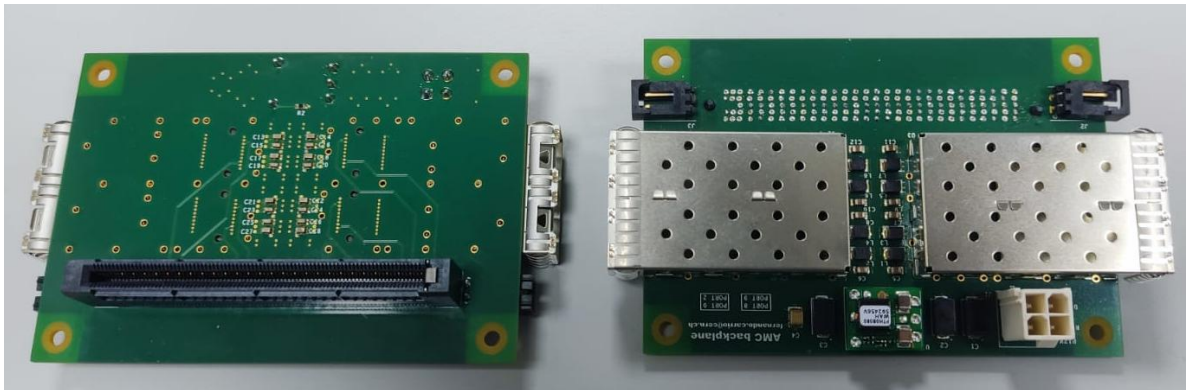
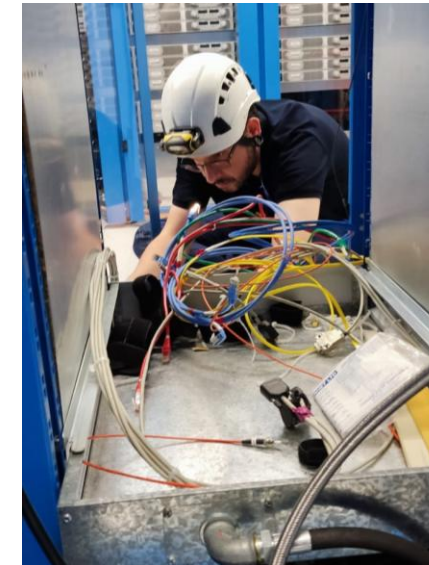
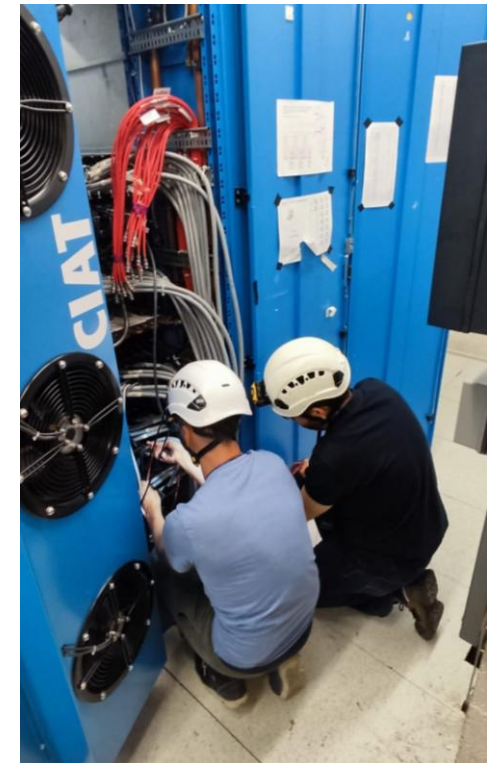
- ✓ • I assembled two AMC backplane boards for laboratory tests.
- ✓ • I also assembled the 3D-printed test box designed by Fernando.
